# TROUBLESHOOT ROD PUMPED WELLS USING TUBING FLUID LEVEL SHOTS

John Sparks, COG OPERATING LLCU  
Lynn Rowlan, Echometer Company

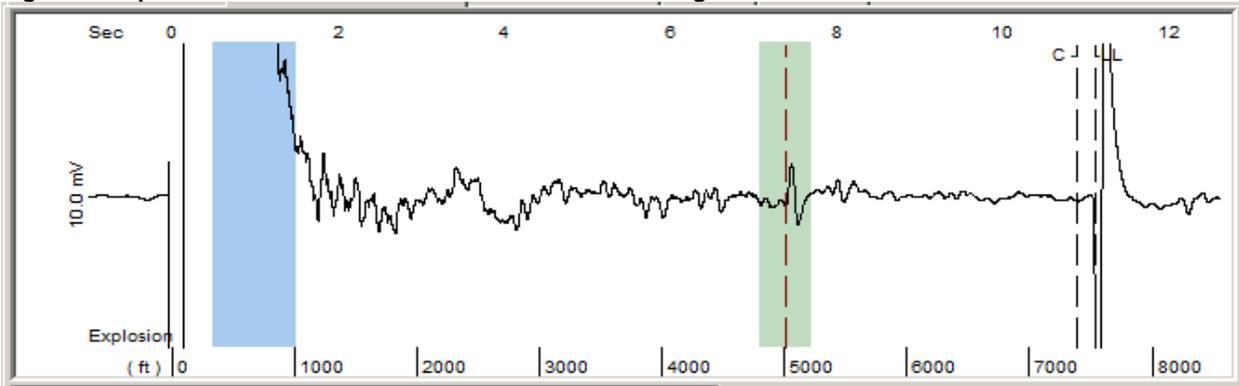
**Fig.1** displays an acoustic trace acquired by shooting down the casing annulus. The liquid level down kick is selected correctly at a RTTT of 11.116 seconds. Direction of kick of echoes on the acoustic traces is used to trouble shoot sucker rod pumped wells having problems. A representative well bore schematic should be used to identify all changes in cross-sectional area along the wellbore. Echoes on the acoustic trace from any change in cross-sectional area should be expected on the acoustic trace at the depth of the anomaly, if the anomaly is above the liquid level. Identifying an unexpected upkick on the acoustic trace at a certain time on the acoustic trace can mean that there is a hole in the tubing. The upkick at a RTTT of 7.389 seconds is due to a hole in the tubing or casing. There is no anomaly shown on the wellbore schematic of this well to indicate an increase in cross-sectional area of the well bore and an upkick echo should NOT be expected at this time/location/depth.

**Figure 1 – Upkick on Acoustic Trace from a Hole in the Tubing**

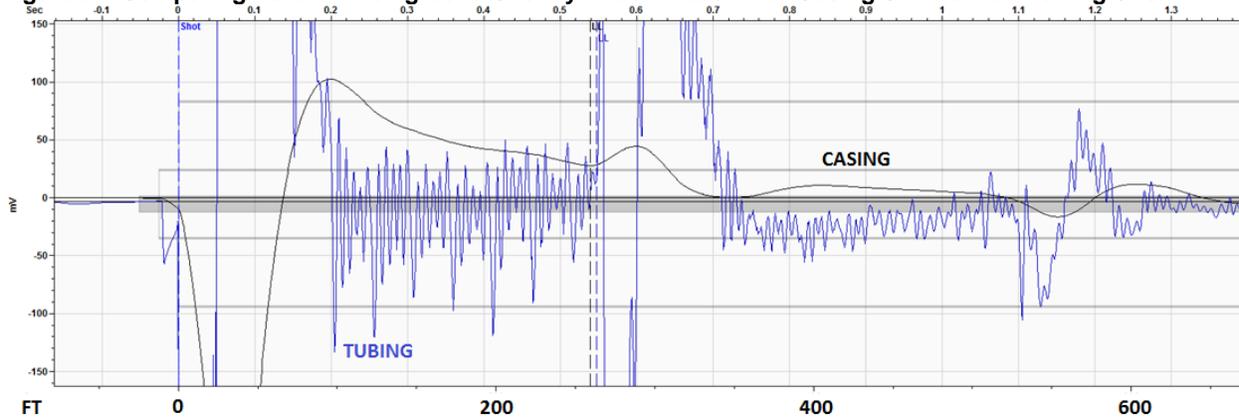
Once the casing fluid level and the tubing fluid levels are properly analyzed, then the tubing and casing acoustic traces can be overlaid and checked for an upkick from the tubing hole appearing on both traces at or near the same depth. The liquid level marker is moved to the beginning of the upkick from the hole on the tubing shot and to the beginning of the upkick from the hole on the casing shot. **Fig. 2** is the overlay plot comparing the acoustic traces acquired on well BKU #554 down the casing and tubing, where the upkick echo from the hole can be seen. Determining the distance to the upkick from the hole in the tubing:

**Figure 2 – Comparing Hole in Tubing Echo Overlay of Low Pass Filter Casing Shot to Raw Tubing Shot**

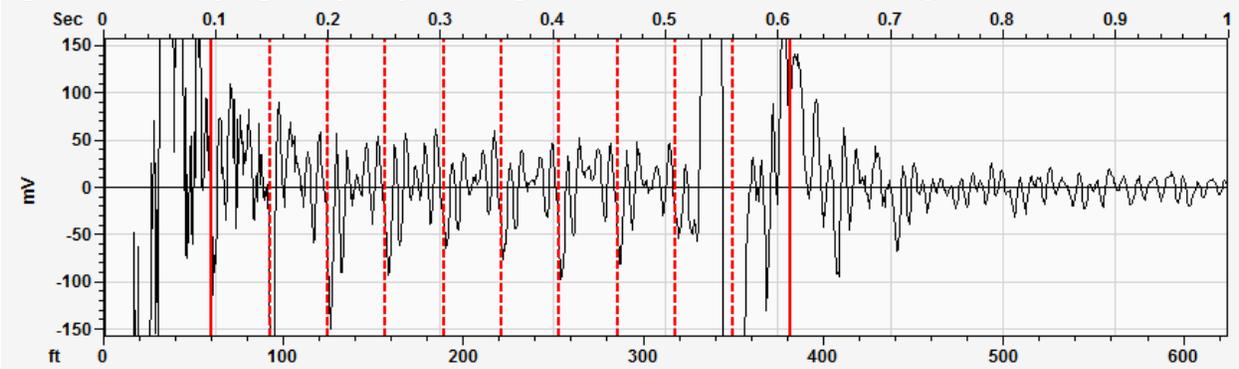
- **Fig. 3** rod couplings frequency down the tubing of  $19.46 \text{ Jts/Sec} * 25 \text{ ft/joint} * 0.541 \text{ seconds RTTT} = 263 \text{ ft}$  to the hole. The tubing pressure at the time of the shot is 48.8 psi(g).
- **Fig. 4** tubing collars frequency down the casing of  $14.96 \text{ Jts/Sec} * 32.15 \text{ ft/joint} * 0.539 \text{ sec RTTT} = 259 \text{ ft}$  to the hole. The casing pressure at the time of the shot is 46.9 Psi(g).

The distance to the hole determined by counting rod coupling versus tubing collar echoes is within 4 foot. The casing acoustic velocity was determined to equal 973 ft/sec and the 0.002 second difference in RTTT between the 2 shots is approximately equal to 1 foot difference in depth to the hole. In the down tubing shot, the rod coupling echoes are present on the acoustic trace; rod coupling echoes are usually seen when shooting down the tubing. To determine the correct acoustic velocity for the steel sucker rod string the average joint length must be changed to 25 foot when counting the rod couplings. Software creates a simple process to zoom into a short time interval along any portion of the acoustic trace. **Fig. 2** compares two acoustic traces by overlaying the portion of the acoustic traces from the surface to the hole.

**Figure 3 - Rod Couplings Frequency in Tubing of 19.46 Joints/second at 25.0 feet/joint**

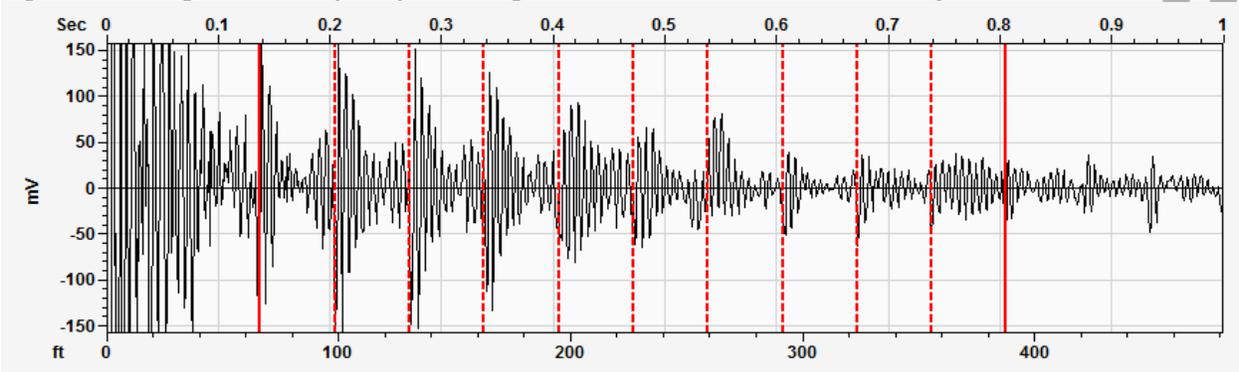
**Figure 4 - Tubing Collars Frequency in Casing of 14.96 Joints/second at 32.15 feet/joint**

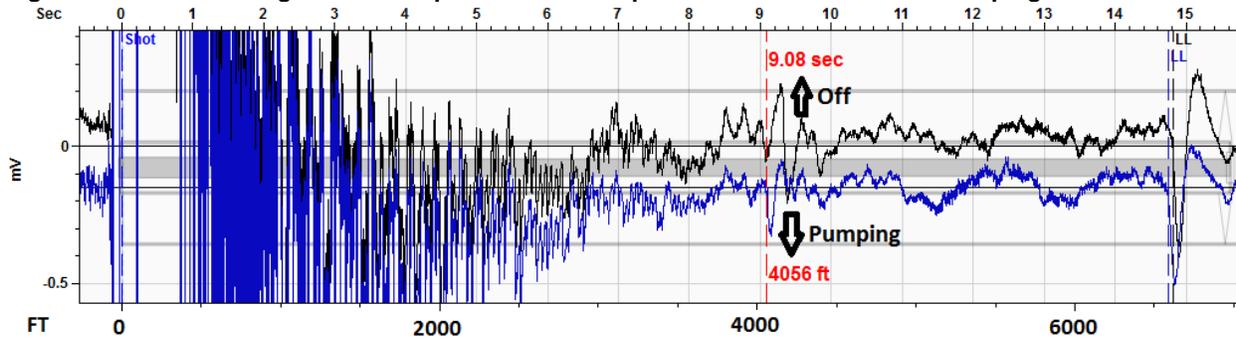
**Fig. 5** is an overlay plot of two acoustic traces acquired down the casing on a rod pumped well where there is a hole in the tubing at 4056 feet from the surface and no liquid is being produced to the surface. The echo from the hole on both acoustic traces is located at 9.08 seconds from the surface. While pumping, a fluid level shot was acquired at 1:48:12 PM. The echo from the hole is displayed as a down kick due to produced liquid discharging from the hole and the liquid discharge is partially filling the wellbore at the hole to create a decrease in cross-section area. With the pump turned off for 50 minutes, a fluid level shot was acquired at 2:38:35 PM. The echo from the hole is displayed as an upkick since all of the liquid in the tubing had enough time to drain out of the split tubing joint thereby creating an increase in cross-section area in the wellbore at the hole. When the pump is producing liquid up the tubing an echo from a hole can be masked or hidden due to liquid filling the tubing at the hole. A recommended practice is to shut the pump down for a period of time to allow any liquid in the tubing above the hole to drain out of the tubing and allow the echo from the hole visible on the acoustic trace.

Figure 5 – Hole in Tubing Shown as Up Kick when Pump Off and Down Kick when Pumping

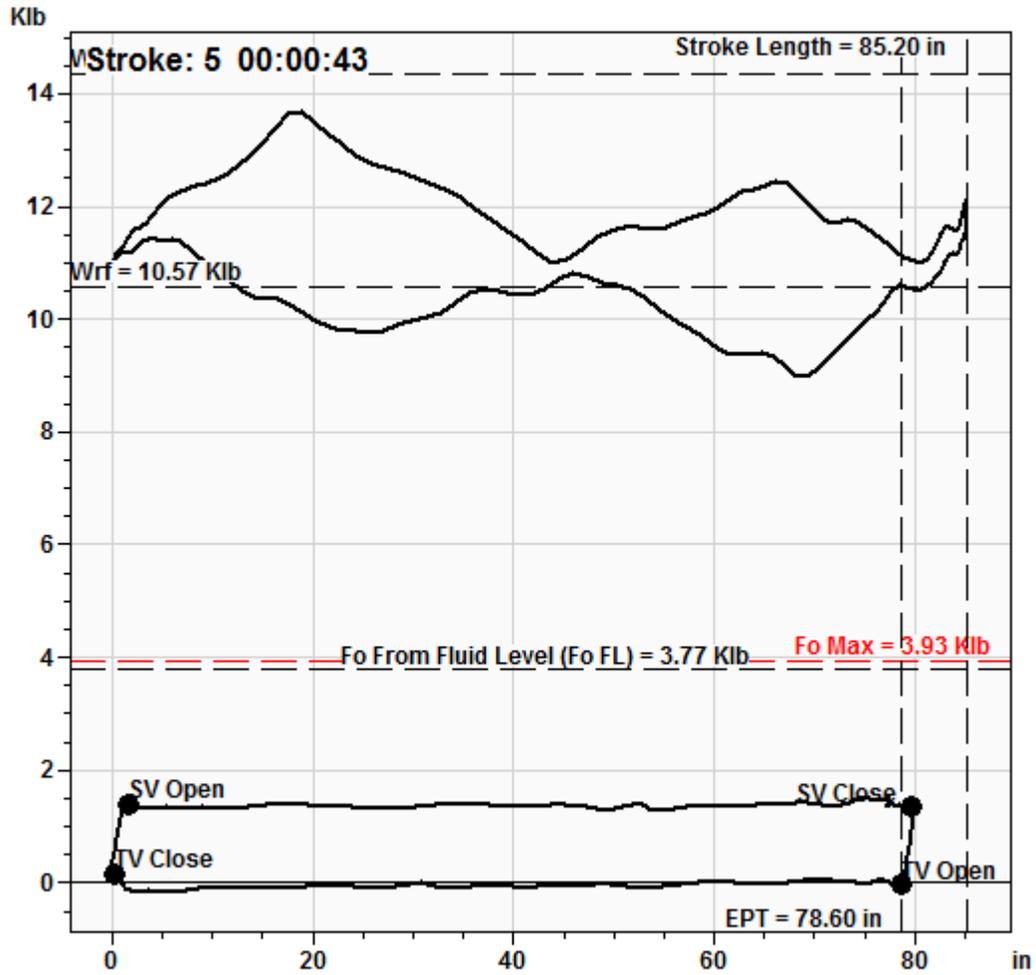
**Fig. 6** shows an abnormally low pump card load of 1355 lbs. The fluid level is 6583 feet from the surface and the pump card loads should be near the 3774 lbs fluid load calculated from the differential pressure acting on the 1.25 inch diameter plunger. The hole in the tubing is 4056 feet from the surface and the pump is lifting liquid up the tubing approximately 2500 feet to discharge out the tubing hole into the casing and circulating liquid back down the casing to keep the pump filled with liquid. The 3744 lbs calculated pump card height is equal the load required to lift the liquid from the pump intake pressure to the surface. The hole in the tubing is 4056 feet from the surface and pump card load on the upstroke is too low because the pump only lifts the liquid approximately 35% of the distance to the surface to discharge out the hole. The reduced height of the pump card can be used as an indicator of a possible hole in the tubing when the net lift shown by the pump card height is much less than fluid load required to

lift the liquid to the surface determined from the fluid level. The full pump card also indicates that there is not a problem with the pump and valves appear to be operating correctly.

Figure 6 – Pump Card Abnormal Loads Due to Lifting Liquid out a Hole and Not Lifting to the Surface

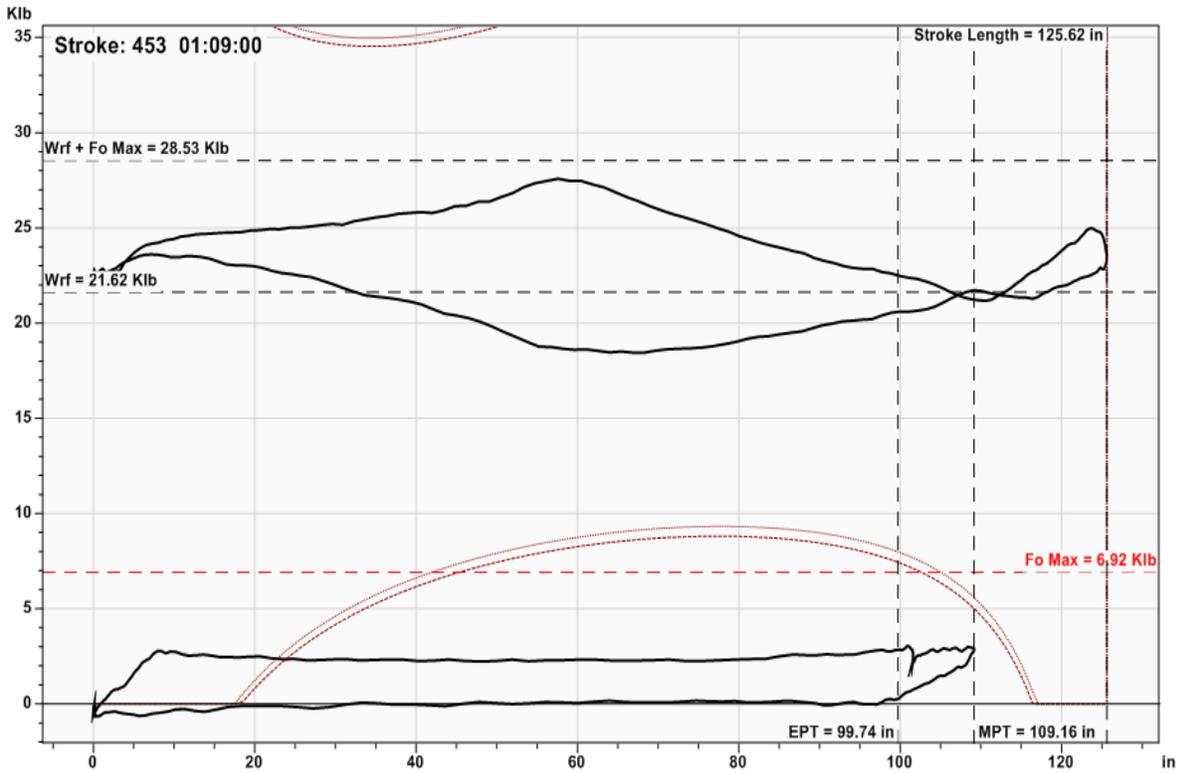
Successive tubing fluid shots in **Table 1** show the pump installed in the well was under-performing and was not pumping sufficient liquid per stroke into the tubing. **Fig. 7** the dynamometer pump card shows good pump action, but liquid was not being pumped into the tubing due to a leaky pump. The pump card shows tubing movement and a valve test on this well could have shown high plunger/barrel leakage (if performed). The fluid level shots down the tubing were used to make the determination on whether or not the pump in this well is truly pumping.

Based on experience from watching other wells “pump up”, there definitely was something wrong with the pump. A visit to the pump shop on the next day discovered that we had mistakenly run a pump with a PAP plunger in this 10,955 foot deep well. With high differential pressure acting across the PAP plunger, lost pump displacement due to slippage accounts for the very slow rise of liquid in the tubing. Initially the well had a high fluid level with low differential pressure acting across the PAP plunger, so the production from the well was good. As the well was produced, the lowered fluid level increased the pressure acting across the plunger and pump slippage increased. When the liquid level was drawn down to 7300 feet from surface, then the pump displacement could not exceed the amount of slippage past the plunger and the pump could no longer lift fluid to the surface. No matter what the “cards” look like, if the fluid level shot down the tubing shows the pump is not bringing fluid to the surface, then it’s time to call the pulling unit. Using an acoustic instrument and shooting fluid levels down the tubing, even without a pump card, an operator can still “make a good call” without incurring the additional expense of a pump truck and determine whether or not his well needs to be pulled.

Figure 7 – Good Pump Action and Not Lifting to the Surface Due to Leaky Pump

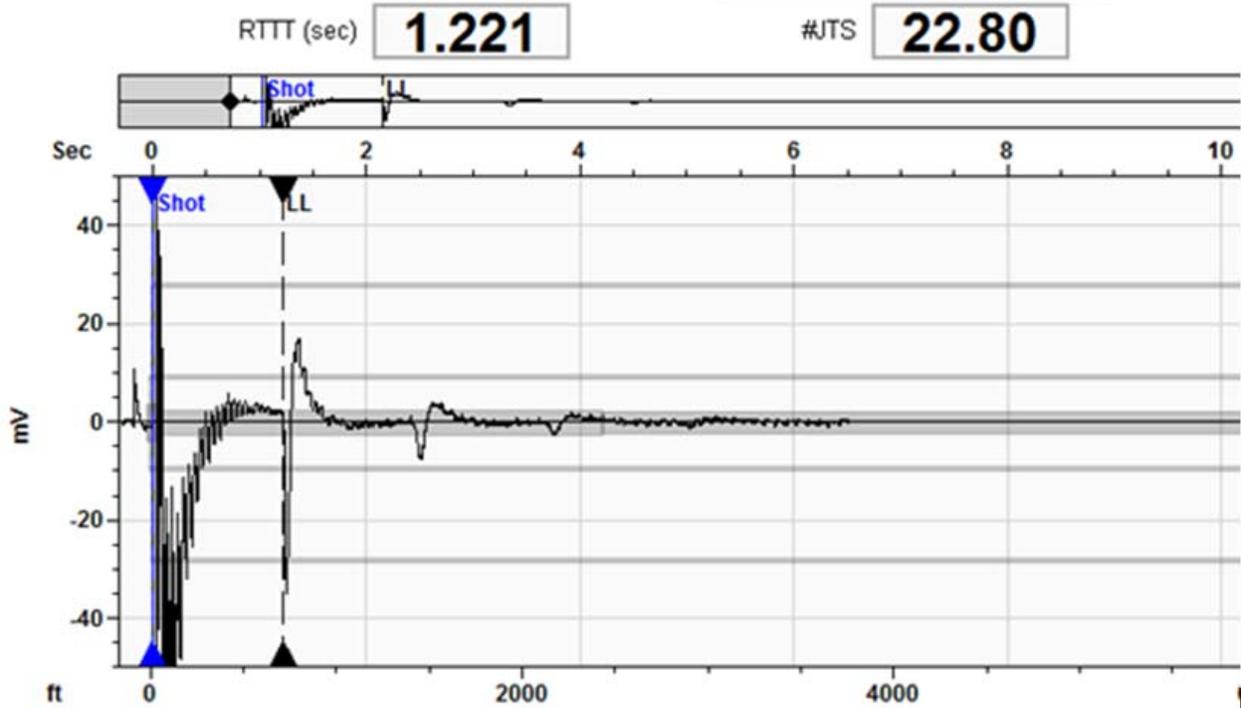
After 53 minutes of continuous pumping a fluid level was acquired on the casing and the distance to the liquid level was determined to be 7300 feet from surface. Thirty-four minutes after taking the casing fluid level shot, there was still no fluid to the surface at the tubing bleeder valve, despite the fact that each pump stroke appeared to be filled with liquid. With no pump slippage at 120 barrels per day pump displacement, the pump should have been filling approximately 3 foot of tubing/sucker rod annular volume per each stroke. **Fig. 8** fluid level acquired inside the tubing at 01:4828PM determined the fluid level was 727.7 feet from the surface, using the acoustic velocity of 1192 ft/sec obtained from the casing fluid level shot.

Liquid was expected to quickly appear at the surface due to the display of relatively good dynamometer cards. With fluid only 727.7 feet from the surface the initial diagnosis was that the well had likely kicked and unloaded a lot of the tubing liquid, but fluid should soon be at the surface. Thirty-one minutes later with no fluid to surface, the

next tubing fluid level shot showed fluid to be 672.9 feet from surface. The fluid level inside the tubing had only risen 55 feet in 31 minutes, rising at a rate of 1.736 feet/minute.

Figure 8 – Fluid Level in Tubing
